NBSIR 78-1582 Report No. 9

# A Metallurgical Analysis of an ASTM A212-B Steel Tank Car Head Plate

September 1978

Federal Railroad Administration

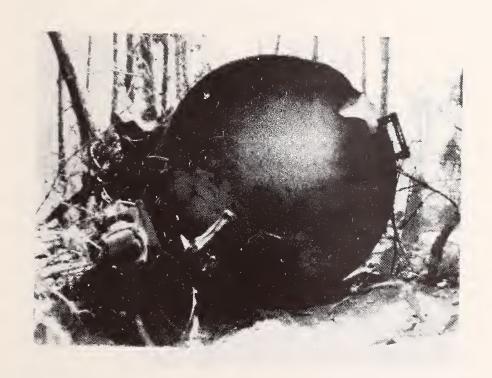
Figure 1. Photograph of Tank Car SOEX 3033 at the Accident Site Near Winder, GA.

The A-head, containing the site of impact, is shown. Original color photograph courtesy of Q. Banks, FRA-DOT.

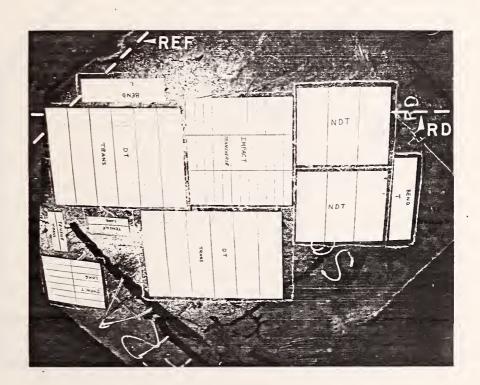
Figure 3. Winder Plate Sample.

Principal plate rolling direction determined with respect to an arbitrary reference line scribed on the plate surface, marked as REF. Chemistry and metallographic samples were taken from locations marked CHEM and MET, respectively.

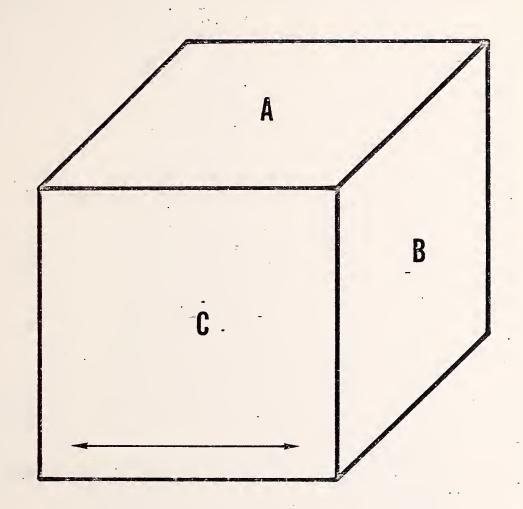
Figure 4. Winder Plate Sample Showing Location and Orientation of Test Specimens.

Principal rolling direction of the plate and arbitrary reference line are shown marked as RD and REF, respectively.

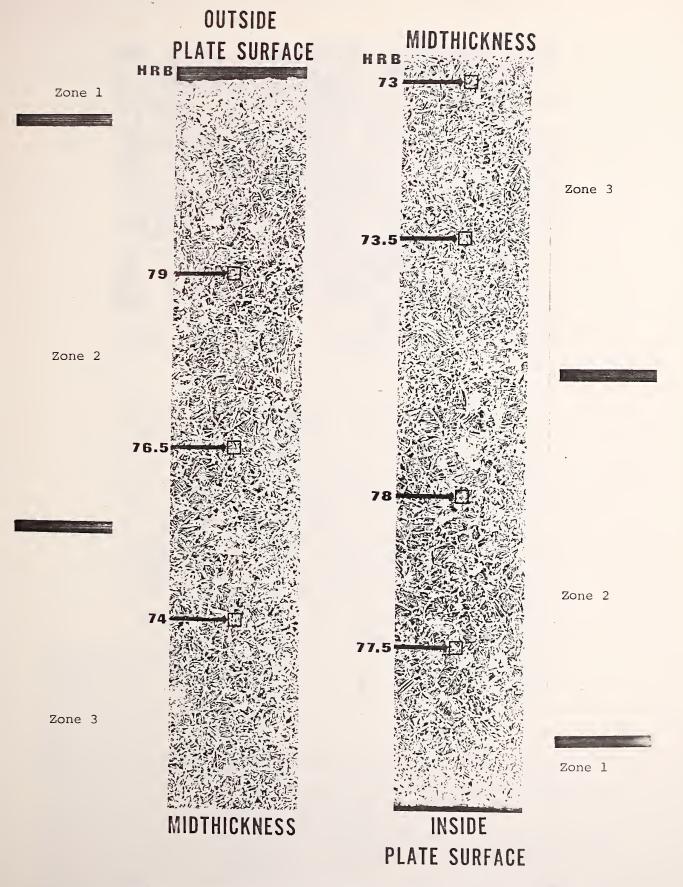
Figure 7. Montage of Microstructure Through Cross-Section of the Plate.
Hardness values are representative of the locations shown.

Representative microstructures are shown in the etched condition in Figures 7 and 8. The microstructure consists of large pearlite colonies and ferrite grains with little evidence of banding and is similar to that reported for another head-plate sample of ASTM A212-B steel [4]. In the present plate, however, there is a high degree of variability from plate surface to plate surface. A montage of the longitudinal plane (Figure 7) microstructure from plate surface to plate surface reveals three distinct zones.

The symmetry of the microstructural zones (Figure 7) about the plate midthickness location is related to thermal and mechanical effects during processing of the plate because the prior austenite grain size and the cooling rate can affect the relative amounts, grain sizes, and distributions of ferrite and pearlite in these low-carbon steels.[10] Large pearlite colonies and a coarse ferrite grain size are two of the factors which promote high impact transition temperatures.

The results of hardness measurements are given in Figure 7. The Rockwell B hardness is highly variable, ranging from 73 to 79, and can be correlated with the microstructure. The region of highest hardness, HRB 77 to 79, corresponds to Zone 2 which exhibits the highest proportion of the relatively hard pearlite phase. The region of lowest hardness, excluding the decarburized layer, corresponds to Zone 3, which consists of extensive areas of the relatively soft ferrite phase.

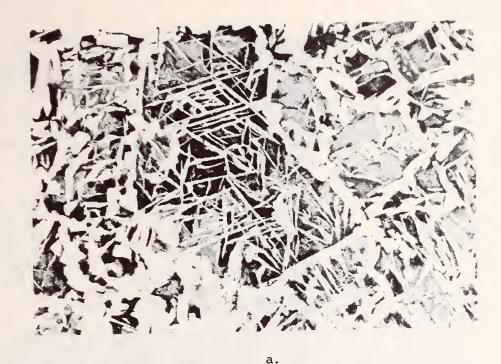
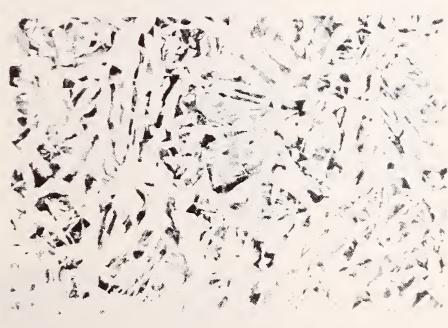
Figure 8. Photomicrographs of Typical Microstructure from Zones 2 and 3.

Proceeding inward from both plate surfaces, the second zone (Zone 2), about 0.19 inches thick, contains large pearlite colonies within which are found acicular or Widmanstatten side plates of ferrite. The pearlite colonies are observed to be generally surrounded by proeutectoid ferrite located on the prior austenite grain boundaries, as shown in Figure 8a.

The determination of the prior austenite grain size was made possible because of the outline of ferrite located at the prior austenite grain boundaries. The prior austenite grain size was estimated to be ASTM No. 1-2 through comparison with Plate I grain size charts from ASTM E 112. The ferrite grain size of the non-Widmanstatten ferrite grains was ASTM No. 7.1 as determined by the circular intercept method from ASTM E 112. The coarse prior austenite grain sizes found in both the Winder plate sample and the other ASTM A212-B head-plate sample previously studied at NBS are consistent with the conclusions that both steels were produced to coarse-grain practice. (d) A coarse austenite grain size will promote the formation of Widmanstatten ferrite in steel containing less that 0.3-0.4 percent-by-weight carbon [9], as seen in Figures 7 and 8.

- Zone 2 Pearlite colonies, surrounded by ferrite grains on a. prior austenite grain boundaries, containing Widmanstätten ferrite.
- Zone 3 Large amounts of ferrite mask prior austenite grain b. boundaries. Widmanstätten ferrite has greatly thickened.

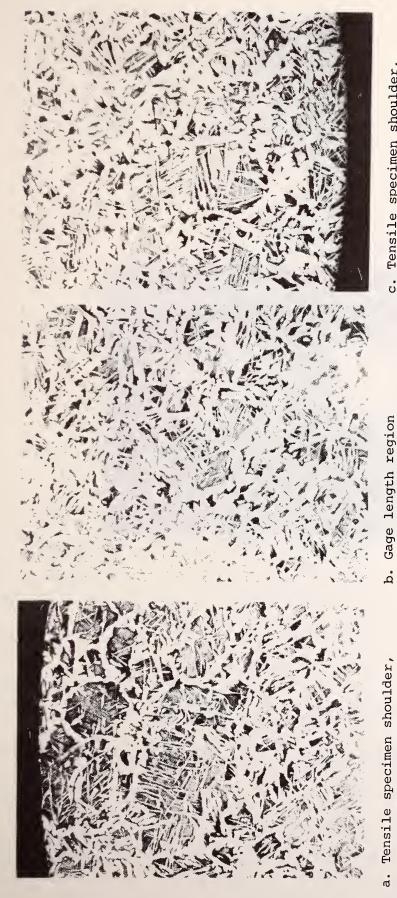
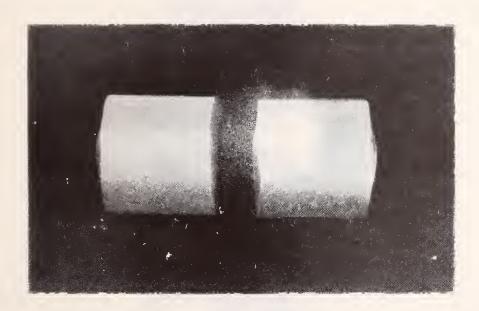
Representative Photomicrographs of a Section Through a Transverse Tensile Specimen Showing the Longitudinal or C Plane Figure 9.

n c. Tensile specimen shoulder, near plate midthickness region

near plate surface

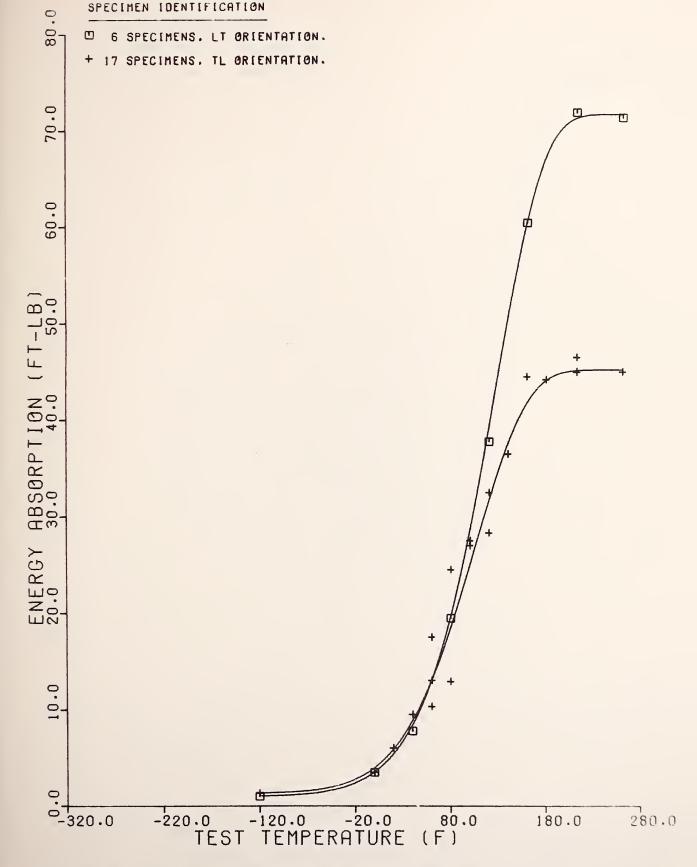
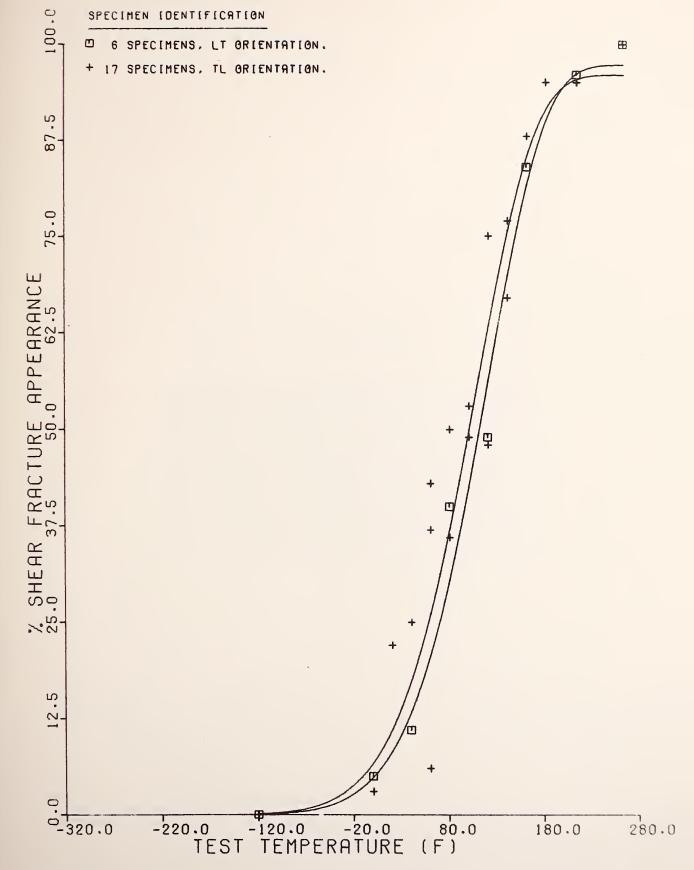
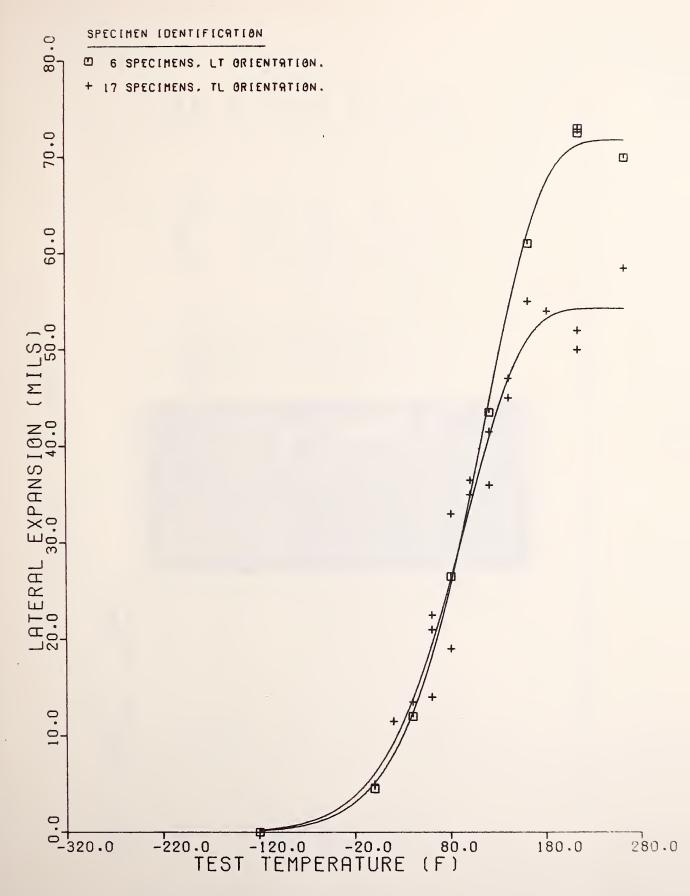
Figure 12a. CHARPY IMPACT TEST RESULTS FOR HEAD PLATE SPECIMENS
TAKEN FROM ASTM A212 STEEL PLATE S

The results of the Charpy V-notch impact tests on both longitudinal and transverse specimens are given in Figure 12. Experimentally measured values and the calculated curves are both shown for three fracture criteria: energy absorption, percent shear fracture appearance, and lateral expansion. The raw data and the results of calculations for the three plots are given in Appendix A, Tables Al through A6. The longitudinal (LT orientation) and transverse (TL orientation) specimens are oriented with the specimen axis parallel and perpendicular, respectively, to the principal plate rolling direction.

The results indicate that at temperatures between approximately 180 F and the highest test temperature of 260 F, there is little variation in the observed behavior of either the longitudinal or transverse specimens. In this upper-shelf region, the percent-shear-fracture appearance, energy absorption, and lateral expansion are at a maximum. For the transverse specimens, however, the upper-shelf energy absorption is only two thirds that of the longitudinal specimens, 45 ft-lbs versus 72 ft-lbs, respectively. This reduced performance of the transverse specimens is further reflected in a lower lateral expansion value of 54 mils compared to 72 mils for longitudinal specimens.

At temperatures below about 180 F, the fracture of Charpy specimens is associated with decreasing amounts of energy absorption, percent-shear-fracture appearance, and lateral expansion with decreasing temperature until at some lower temperature all three criteria reach a minimum level called the lower shelf. At temperatures between the upper shelf and the lower shelf, there is a transition zone.

The results indicate that for each of the fracture criteria, the transition zone lies in approximately the same range of temperature, a range of 200 F between -20 F and +180 F. At temperatures below about 100 F, the value of the fracture criteria are independent of specimen orientation while at all higher test temperatures the energy-absorption and lateral-expansion values are greater for the longitudinal specimens.

The reportedly [1] brittle fracture appearance of the failed Winder head plate is consistent with the measured Charpy impact transition temperatures. The Winder plate has a 15 ft-lb transition temperature of 66 F. This is 26 F above the tank car service temperature at the time of the accident.
